## Another Solution from Mar. 2019 ROCKFORD DRIVE LINE

Can we replace the "Staked-In" u-joint that Jeep used on the 2007-2018 Wrangler JK front shaft?

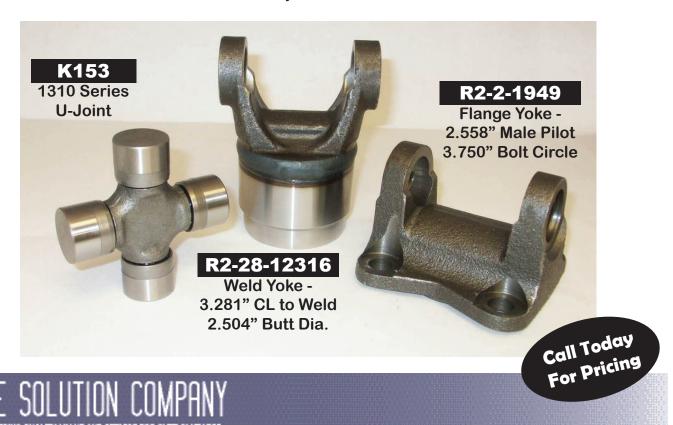
The factory original front driveshafts found on Jeep Wrangler JK models from 2007-2018 have a non-replaceable staked-in style u-joint. With the

Rockford Driveline parts below you are able to cut the Original assembly apart 1/8" below the friction weld and replace the Weld Yoke, Flange Yoke & U-Joint with a servicable 1310 system.
